#PIC5136H: Clicking Noise From Front Wheels - (Jun 8, 2012)
Subject: Clicking Noise From Front Wheels

Models: 2009 - 2012 Cadillac CTS-V

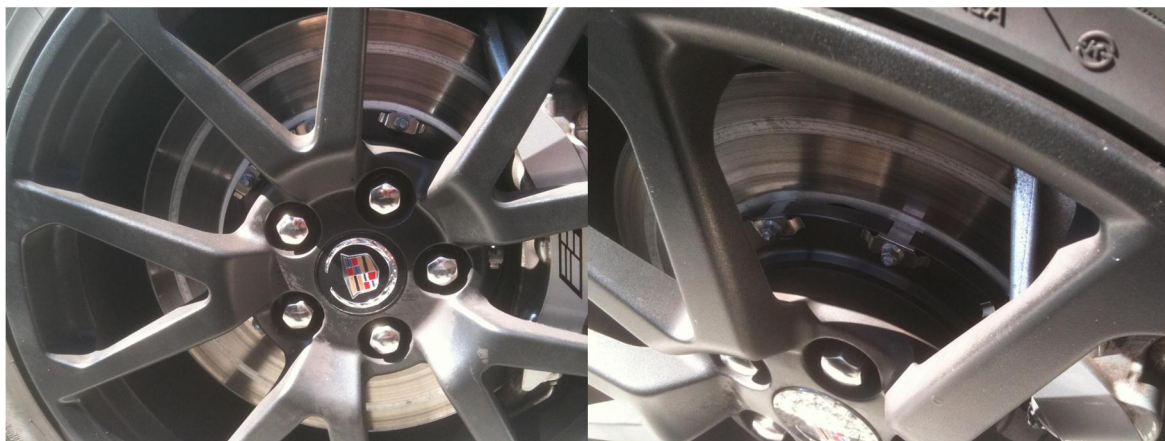
The CTS-V has lightweight high performance front rotors with an aluminum center. The clicking sound is caused by interaction between the wheel mounting face and wheel mounting surface on the brake rotor caused by the aluminum-to-aluminum interface.

This condition was previously temporarily remedied through cleaning the rotor and wheel interface. **Please STOP doing that cleaning procedure now, and instead replace both front rotors with part numbers listed below:**

Left Hand Rotor - 20795300

Right Hand Rotor - 20795302
